AEFA PROJECT NO. 83-13

JUH-1H REDESIGNED PNEUMATIC BOOT DEICING SYSTEM FLIGHT TEST EVALUATION

AUGUST 1987

FINAL REPORT

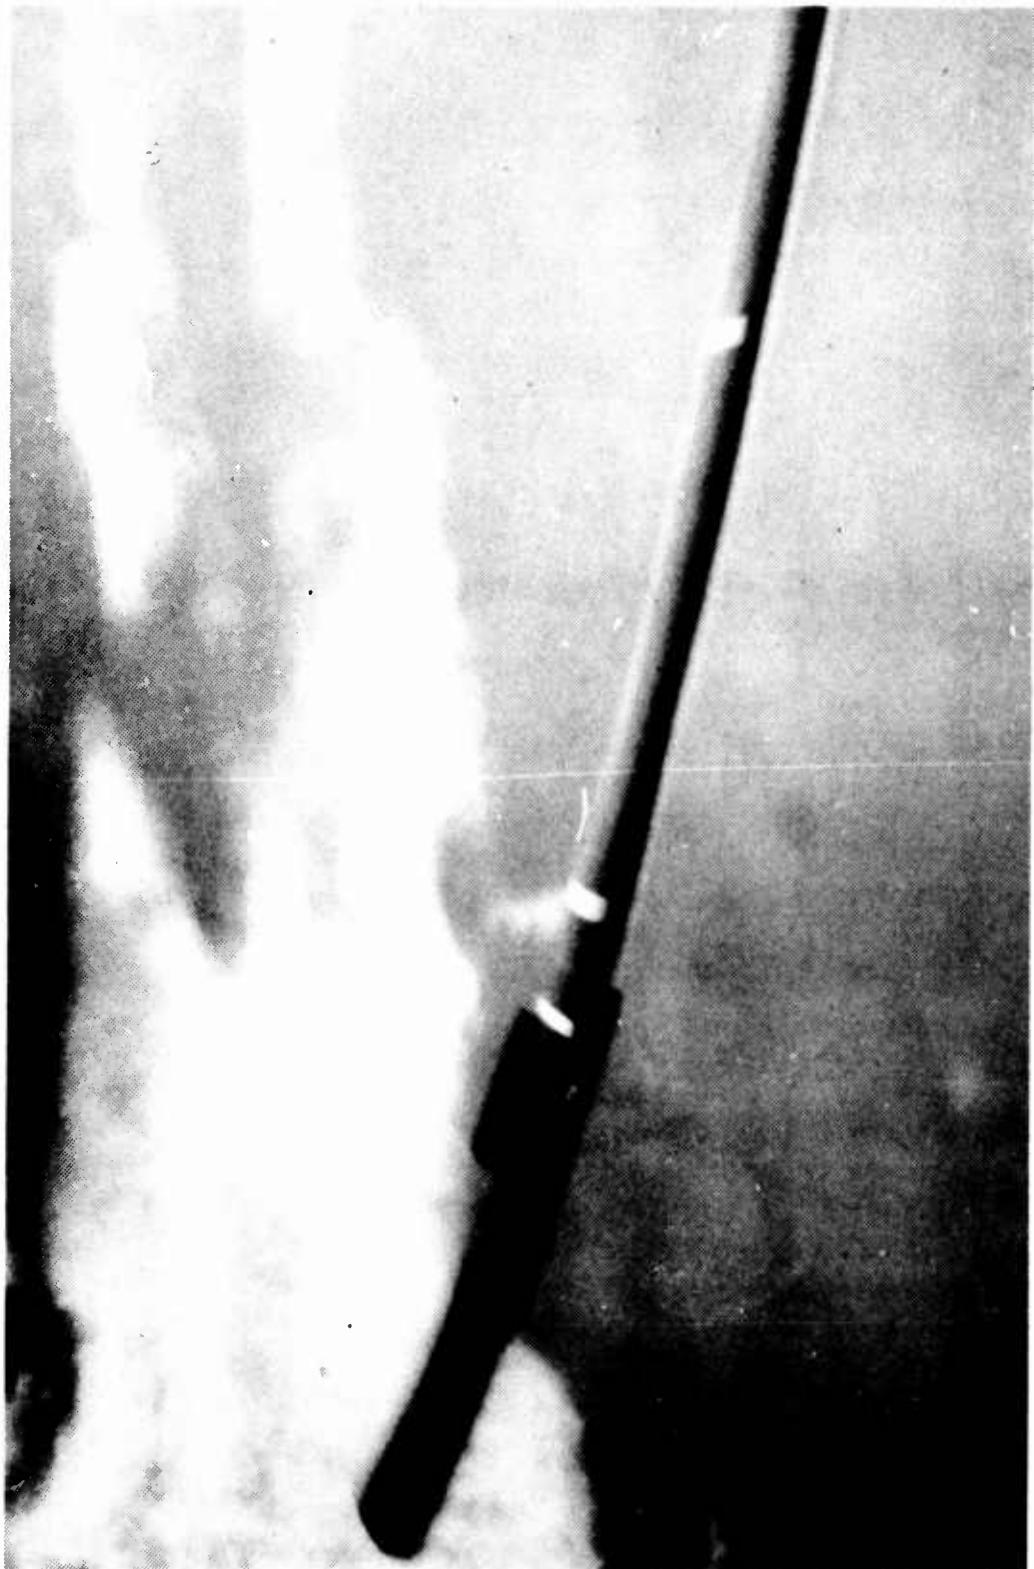
27. The outboard section of the main rotor blade (outboard of blade station 244) which included the non-inflatable portion of the deicer boot was naturally self shedding (photo 8, app G). Ice accretion on the non-inflatable section of the deicer was only observed at temperatures below -15°C. Self shedding of the non-inflatable area occurred without buildup of vibration levels. This was probably due to the lower ice adhesion characteristics of the ESTANE® deicer surface when compared to the standard UH-1H metal airfoil. The lowered adhesion level would allow the accreted ice to self-shed prior to ice accretion of sufficient mass to result in significant lateral vibration. Reduction of the span wise pneumatics should be further investigated since this would reduce profile drag, vibration levels, susceptibility to pneumatic tube impact damage, and improve handling qualities during PBDS activation.

Photo 8. Self Shedding of Tip

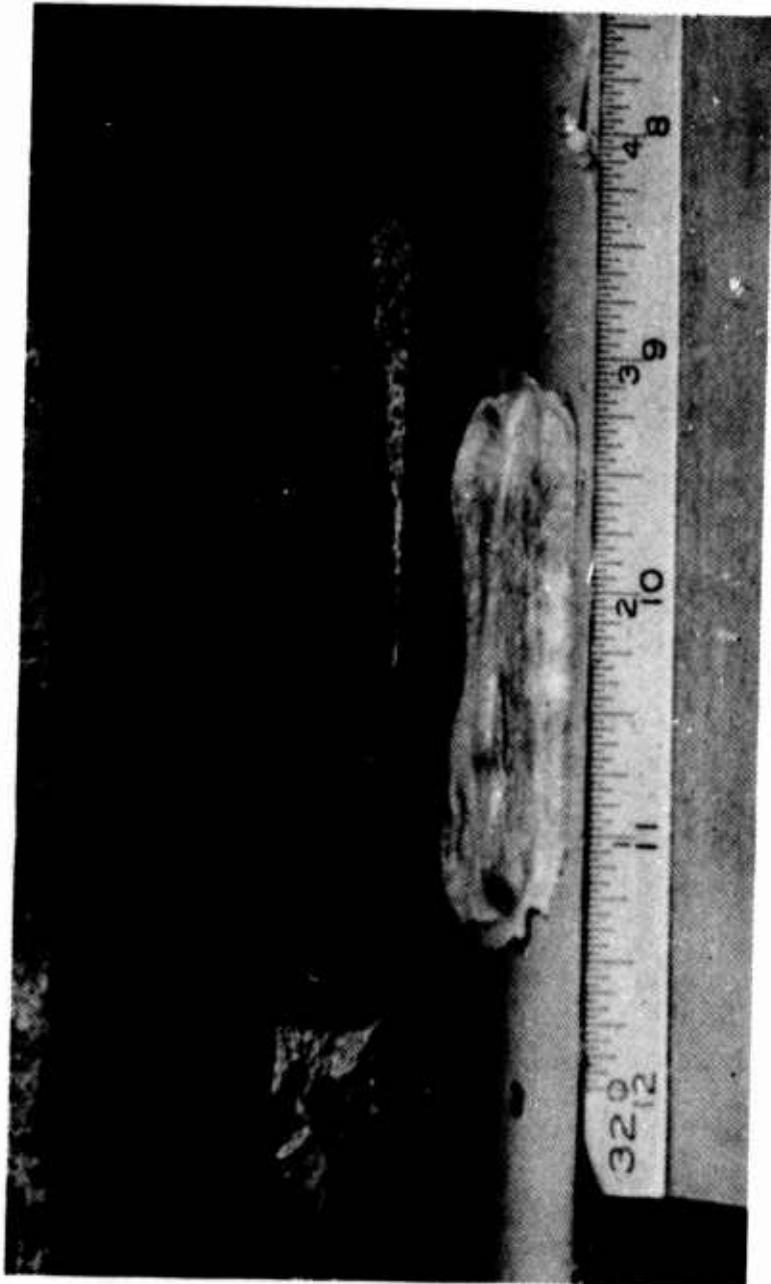
44. After a 20 minute icing flight damage to the damper control tubes as shown in photo 12, appendix G was discovered. The steel-wire wrapped pneumatic hose (photo 13) leading from the pneumatic slip ring assembly to the main rotor blade flap assembly rubbed against the damper control tube causing damage which required replacement of the control tube. A combination of factors such as a loosened plastic fastener, accreted ice on the hose and centrifugal force probably contributed to the rubbing action. Use of steel wire wrapped pneumatic hose is a potential problem area when placed near moveable control surfaces as in the current test installation, and is unsatisfactory. Extreme caution should be used during the pneumatic tube installation. Preflight and postflight inspections of the damper control tube area should be emphasized.

Photo 13. Abrasion of Damper Control Tube
